Avnet Ultra96-V2
Revision 1 Errata
14 June 2019

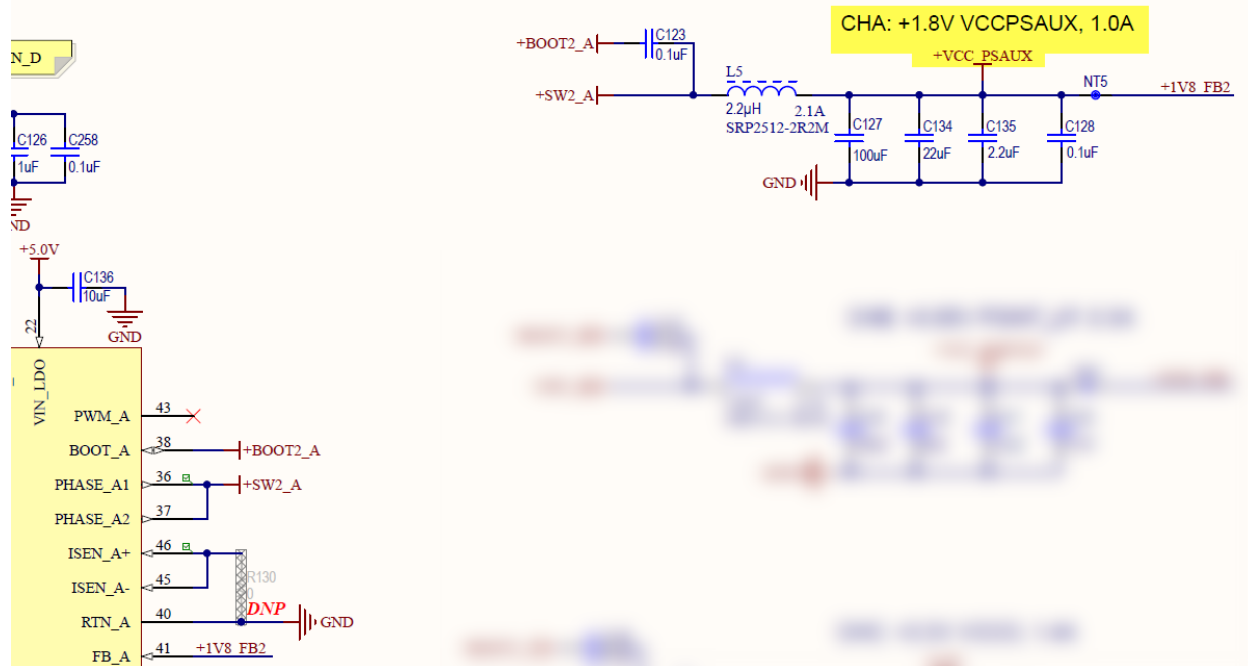
Figure 3 – Ultra96-V2 Schematic Page for Pmic #2, 0x14

The Infineon Pmics used on Ultra96-V2 are programmable devices that include voltage value, warning, and fault settings. Reference Designator U12 is an Infineon IRPS5401 with an address setting of 0x14. Switcher A on this device delivers 1.8V to the Ultra96-V2 which is VCC_PSAUX. this can be seen on Sheet 16 of Ultra96-V2 Rev 1 schematics. This rail was designed to deliver a maximum steady-state current of 1.0A.

For the affected boards, the warning threshold was set too low, such that occasional current spikes will trigger an over-current warning. This is only seen if actively monitoring in the Infineon PowIRCenter software, as shown in the figures below. The warning does NOT affect the proper operation of the board.

It is not necessary to perform a work-around. This warning may be safely ignored. However, the Infineon Pmic warning thresholds may be adjusted to 1.5A to eliminate this warning.

The programming files will be adjusted to eliminate the warning on boards with datecode 1931 or later.

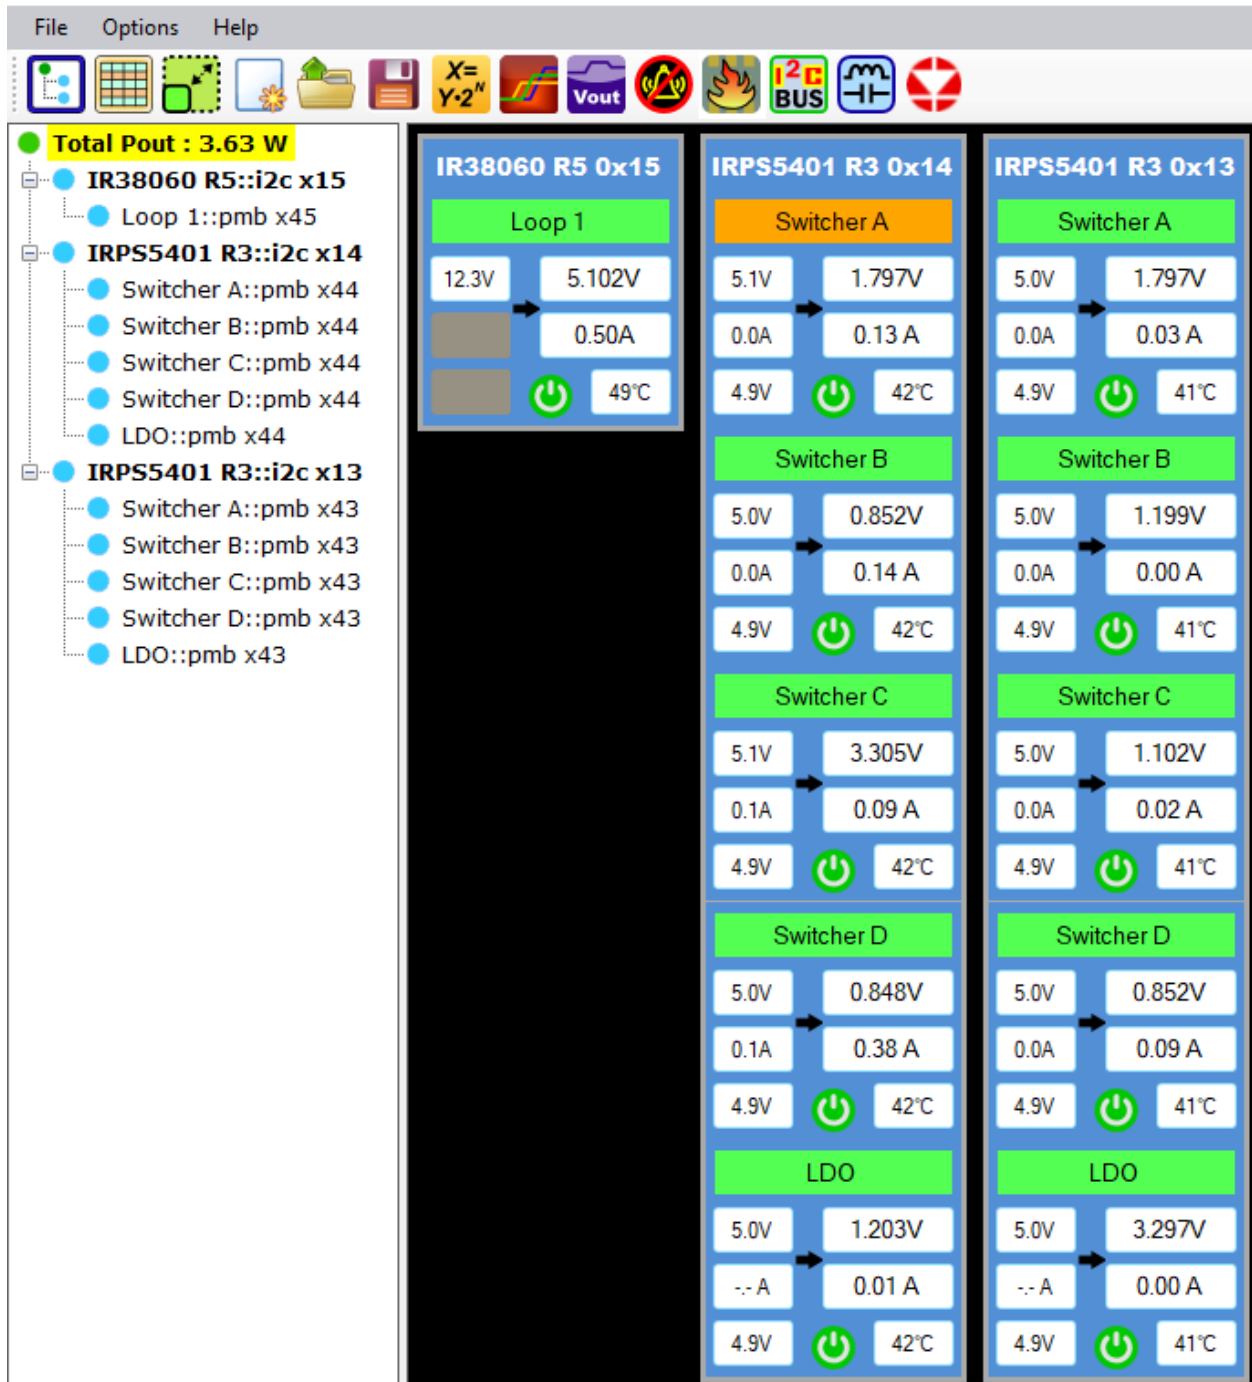
Figure 4 – PowIRCenter Shows Warning on Switcher A of 0x14

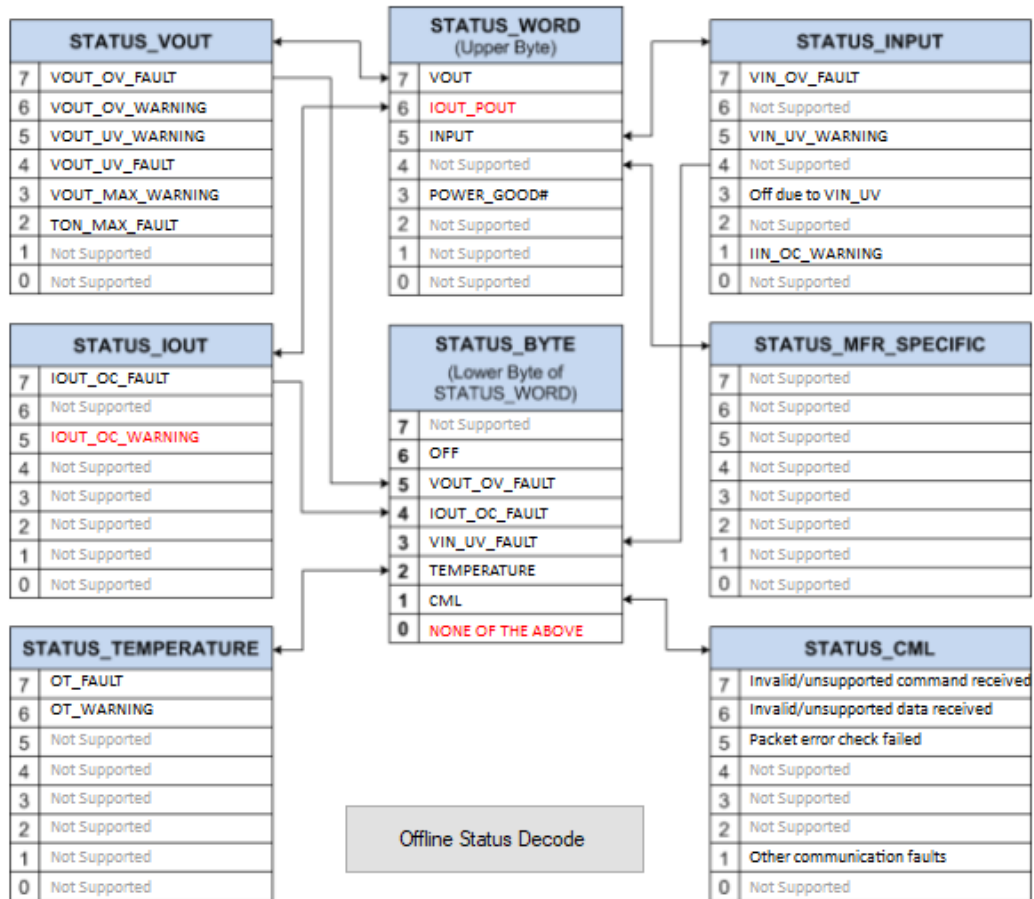
Figure 5 – Detailed Warning Shows IOUT Over-Current Warning
