# MicroZed Errata

Thank you for your interest in the Zynq 7Z010/7Z020 MicroZed board. Although Avnet has made every effort to ensure the highest possible quality, these boards are subject to the limitations described in this errata notification. This document pertains to MicroZed Revision B, C, and F boards (revision D & E MicroZed boards were not produced).

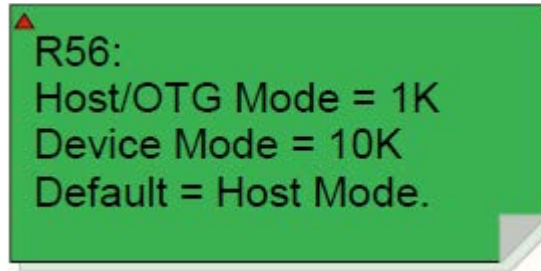
MicroZed uses a MicroChip USB3320 device for the USB Host circuit. On Sheet 5 of the MicroZed schematics, see the following note:

This is incorrect. This resistor is the  $R_{VBUS}$  resistor, which according to the USB3320 is specified to be:

Since the default operating mode on MicroZed is Host Mode, R56 should be 10K $\Omega$  but it is populated incorrectly as 1K $\Omega$ .

Change R56 to 10K $\Omega$ .
