ERRATA

August 1, 2025

AUBoard-15P Development Kit – Revision 1

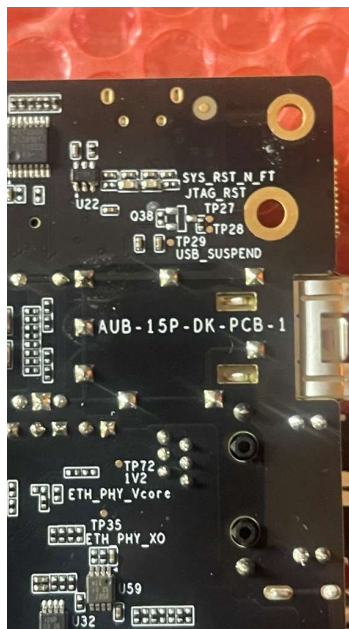
Board Bottom Side View

The AUBoard-15P Development Kits affected by these errata can be identified by the PCB Revision listed in silkscreen on the back of the PCB. The PCB Revision of the AUBoard-15P is listed in silkscreen and can be found on the bottom side of the board near the top right edge by the SFP connector. The current production revision is "AUB-15P-DK-PCB-1". Boards that are at this production revision are affected.

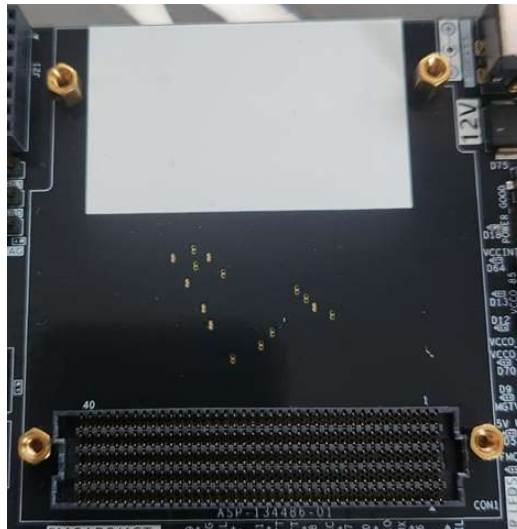
AUBoard-15 FMC Add-On Location

Incorrect Silkscreen / Mounting Holes for FMC Add-on Cards

Description – It has been determined that the silkscreen and the top mounting holes for the FMC add-on card location were accidentally inverted. The images below show the AUBoard-15P and a comparison to a platform with the appropriate silkscreen and top mounting holes.

Workaround – The AUBoard-15P top mounting hole alignment is skewed. A potential solution for mounting may be to make use of smaller hardware components to provide flexibility to mount with. Aside from this, the misalignment and silkscreens will be corrected in Revision 2 of the AUBoard-15P.
