ERRATA

January 5, 2025

Versal AI Edge - VE2302 Development Kit – Carrier Card - Revision 1

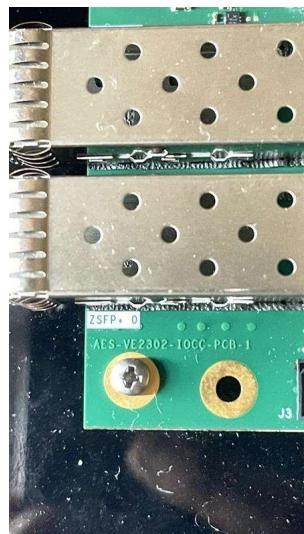
Board Bottom Side View

The PCB Revision of the VE2302 Carrier Card is listed in copper and can be found on the top layer of the board near the card edge by the SFP connectors. The current production revision is "AES-VE2302-IOCC-PCB-1". Carrier Boards that are at this production revision are affected.

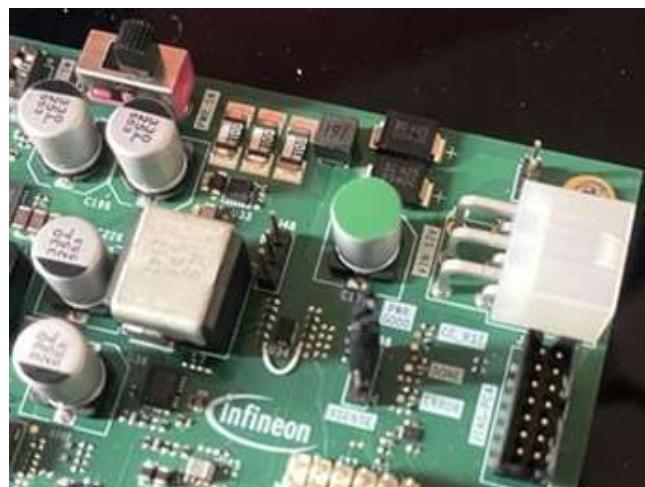
Power Sequencing White Wire

Circuit monitoring +VCC_RAM for power sequencing not triggering

Description – The +VCC_RAM power rail is included in the power sequence monitoring of the VE2302 Carrier Card. Unfortunately, the +VCC_RAM power rail does not generate a power good signal to provide an indicator that the supply is functional. The circuit used to signal power good to the power sequencer was not capable of reliably triggering as +VCC_RAM voltage is +0.8V nominal.

Workaround – All available Revision 1 VE2302 Carrier Cards contains a WHITE WIRE rework to ensure that the VE2302 Carrier Card power sequencing completes correctly. This WHITE WIRE rework should be visible near the 12V power connector just to the right of the large inductor.

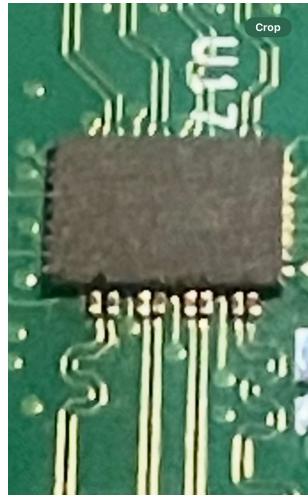
HDMI RX AC Coupling Capacitor Rework

Missing Required AC Coupling Capacitors on HDMI RX Interface

Description – It has been determined that AC coupling capacitors were not implemented on the HDMI RX interface between the TMDS1204 HDMI re-driver device, U17, and VE2302 device that exist on the Versal SOM.

Performance Limitation – HDMI RX not functional on Revision 1 Carrier Cards. This functionality is resolved in Revision 2 platforms. Revision 1 platforms are limited to those customers who do not require HDMI RX functionality.

For clarity, the rework requires the addition of eight (8) 0201 100nF capacitors on the 4 RX differential pairs. This requires careful trace exposure, trace cutting, and then the installation of the eight capacitors in the path. The following is an image of the rework performed on the Revision 1 Carrier Card to support HDMI RX functionality:
